Manhole Inspection Summary

Manhole # S45I2_005MH

Insp Date: 1/11/08 8:09 AM

Location Address: **Pennington Ave.**

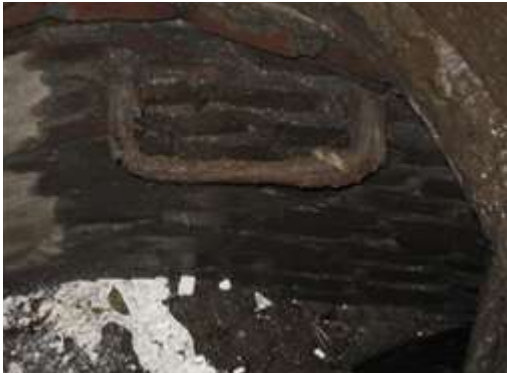
Count: **1** Missing: **0** ☒ **Corroded**

steps

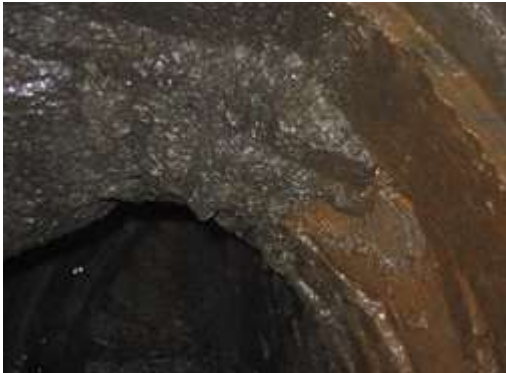
Defect 2

Offset: **2** (in.)

frame offset

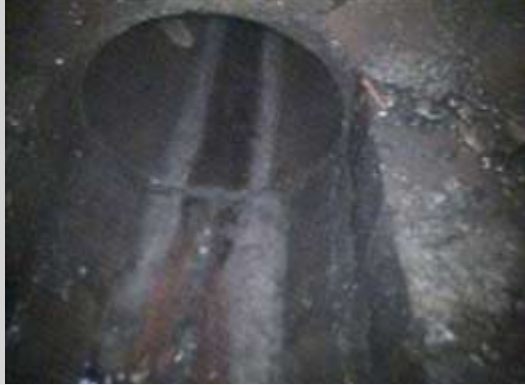
12 O'Clock Outflow

Pipe Height: **7.2** (in.) Rod and Bar (Angled)
Pipe Material: **Clay** ☐ Pipe Lined
Invert Depth: **9.06** (ft.) Flow Characteristics: **Slow**
Deposits: ☒ None ☐ Mud ☐ Sludge ☐ Debris ☐ Grease
Silt Depth: (in.) Deposits Extent:
Infiltration: **None** Pipe Seal Cond: **Sound**

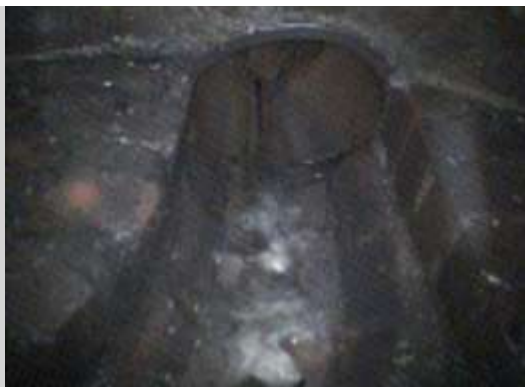
5 O'Clock Inflow

Pipe Height: **7.2** (in.) Rod and Bar (Angled)
Pipe Material: **Clay** ☐ Pipe Lined
Invert Depth: **9.12** (ft.) Flow Characteristics: **Slow**
Deposits: ☒ None ☐ Mud ☐ Sludge ☐ Debris ☐ Grease
Silt Depth: (in.) Deposits Extent:
Infiltration: **None** Pipe Seal Cond: **Sound**

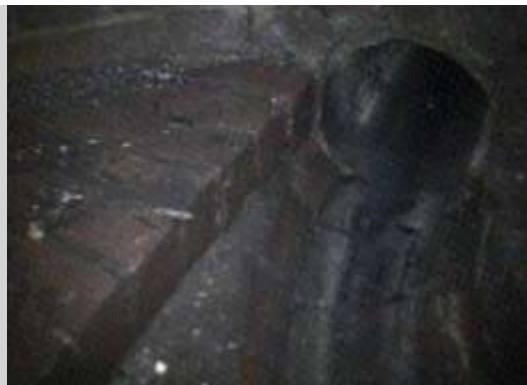
7 O'Clock Inflow

Pipe Height: **8.4** (in.) Rod and Bar (Angled)

Infiltration: **None** Pipe Seal Cond: **Sound**
